CLEAN WATER ACT
COMPLIANCE INSPECTION

Facility Name

On-Site June 16, 2011

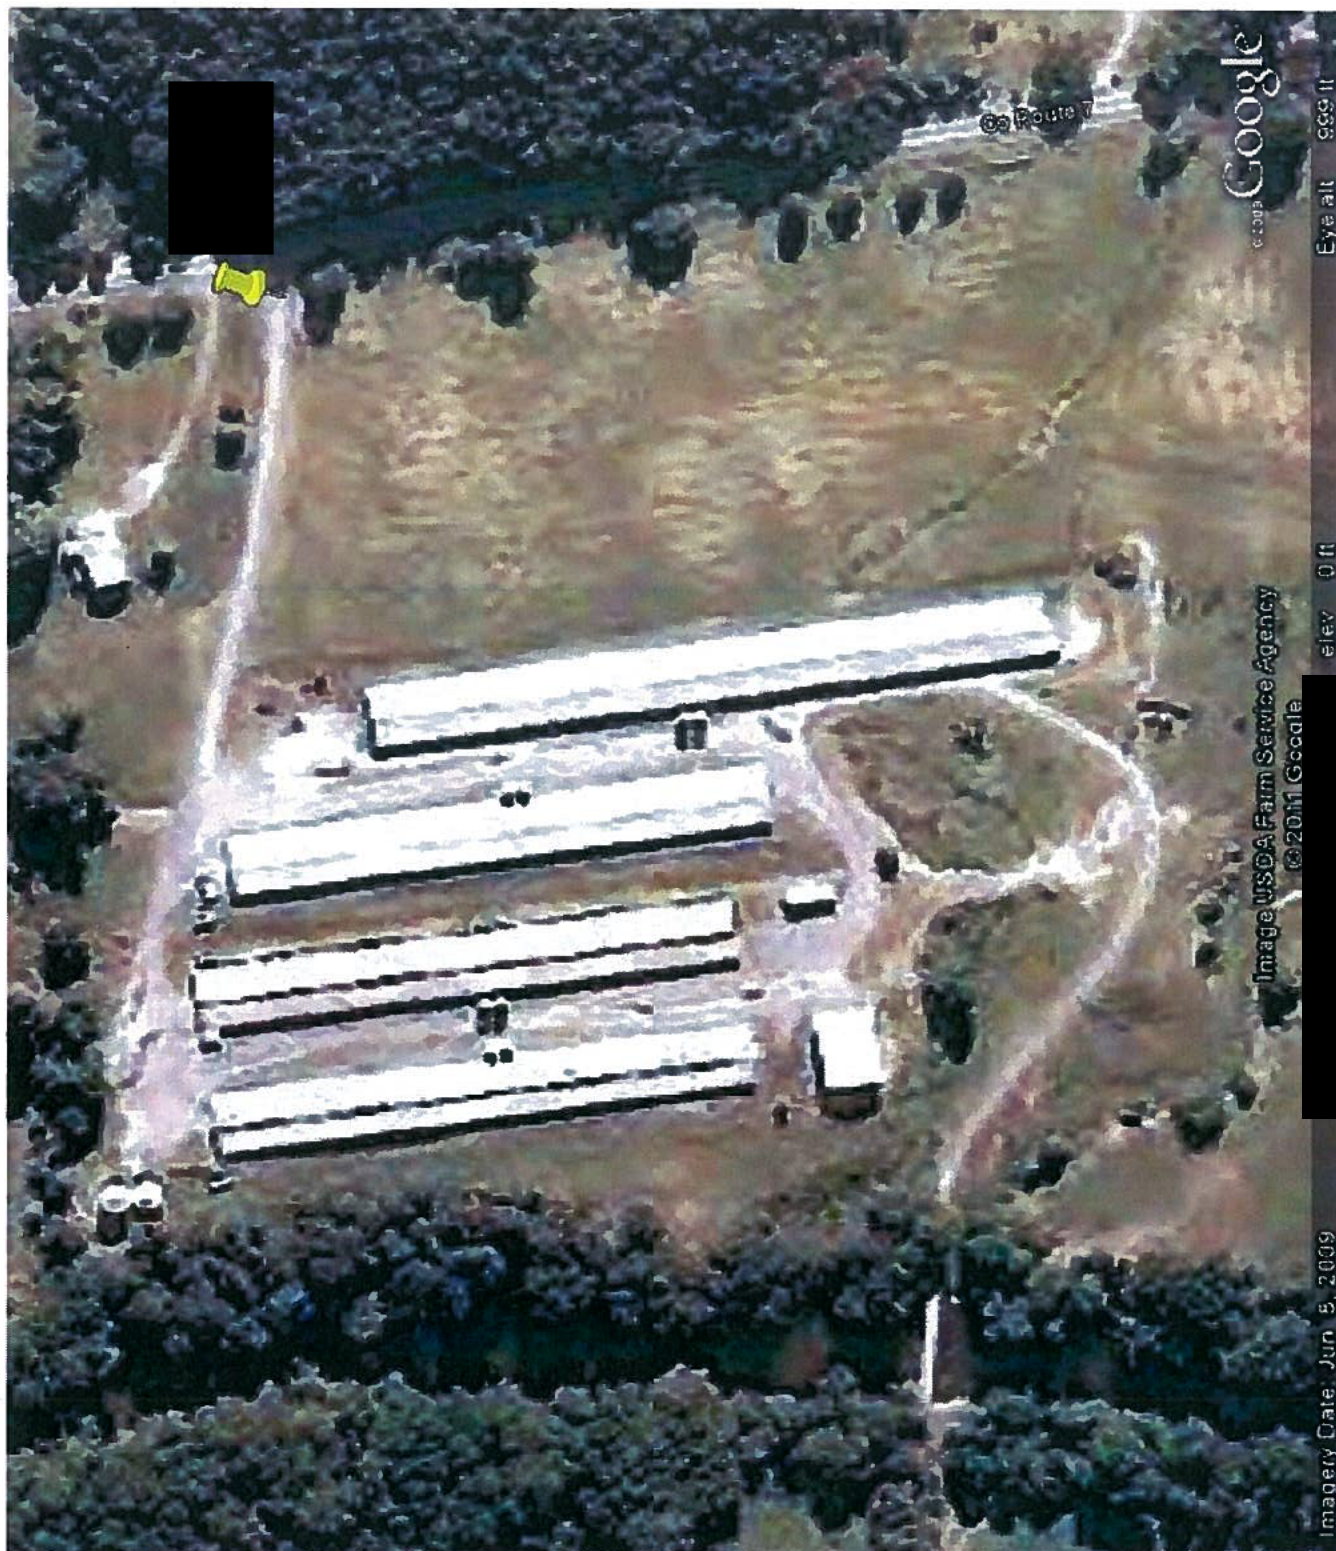
Site Map 1

From interpolation of satellite imagery from Google Earth, the coordinates at the entrance (nearest to Poultry House 4) to the Facility are [REDACTED] and indicated by the yellow thumb tack on Site Map 1. The facility is owned by [REDACTED]. At this Facility, [REDACTED] raises broilers under contract with [REDACTED], and has for the last five years ([REDACTED]). The facility consists of four poultry houses, two manure sheds, and a compost shed. These structures, except for the off-site manure shed, are as labeled on Site Map 2. The poultry houses are referred to as numbers 1 through 4 with house number 1 being in the back of the property and house number 4 being closest to the front entrance. Houses 1 and 2 were built in 1987. House 3 was built in 1990. House 4 was built in 1993. Houses operate under the same [REDACTED] contracts as follows:
